RAILWAY INVESTIGATION REPORT
R04H0009

CROSSING COLLISION

VIA RAIL CANADA INC.

MUNSTER, ONTARIO

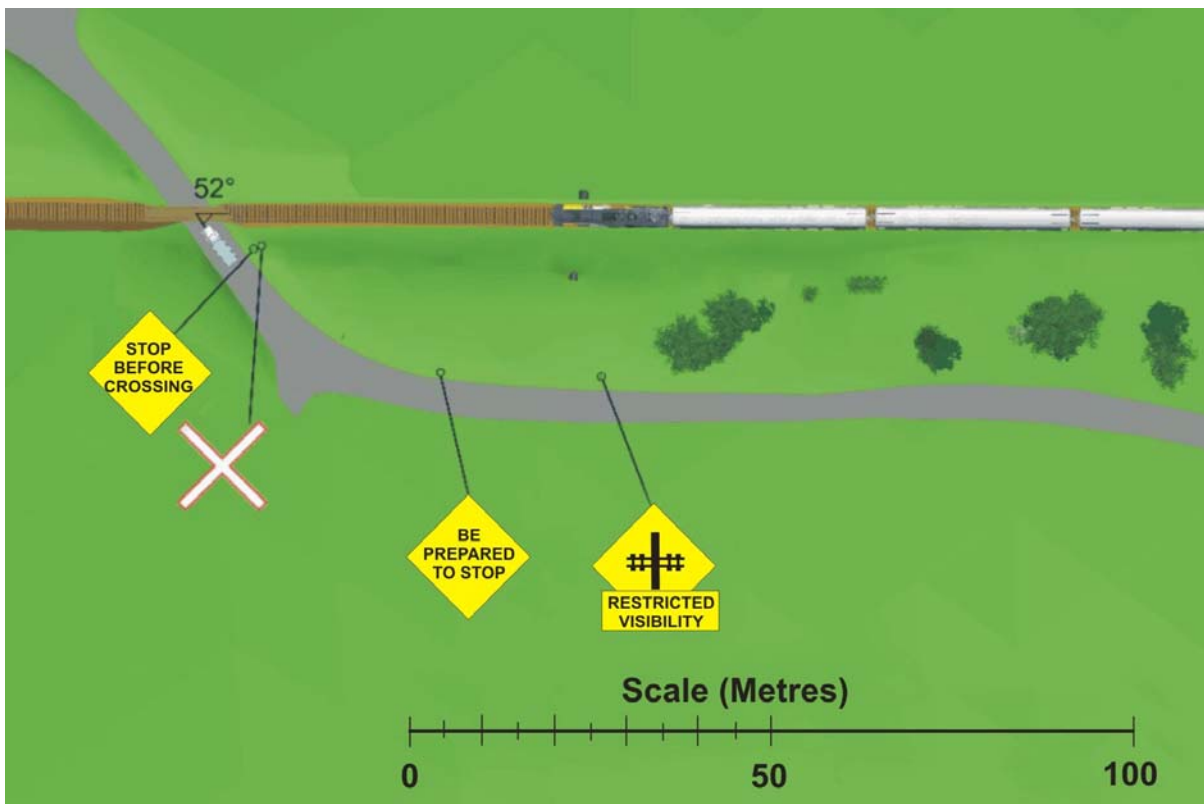
Figure 1. Overhead schematic of Kettles Road crossing, approximately 10 miles southwest of the Ottawa suburbs, just east of County Road 3

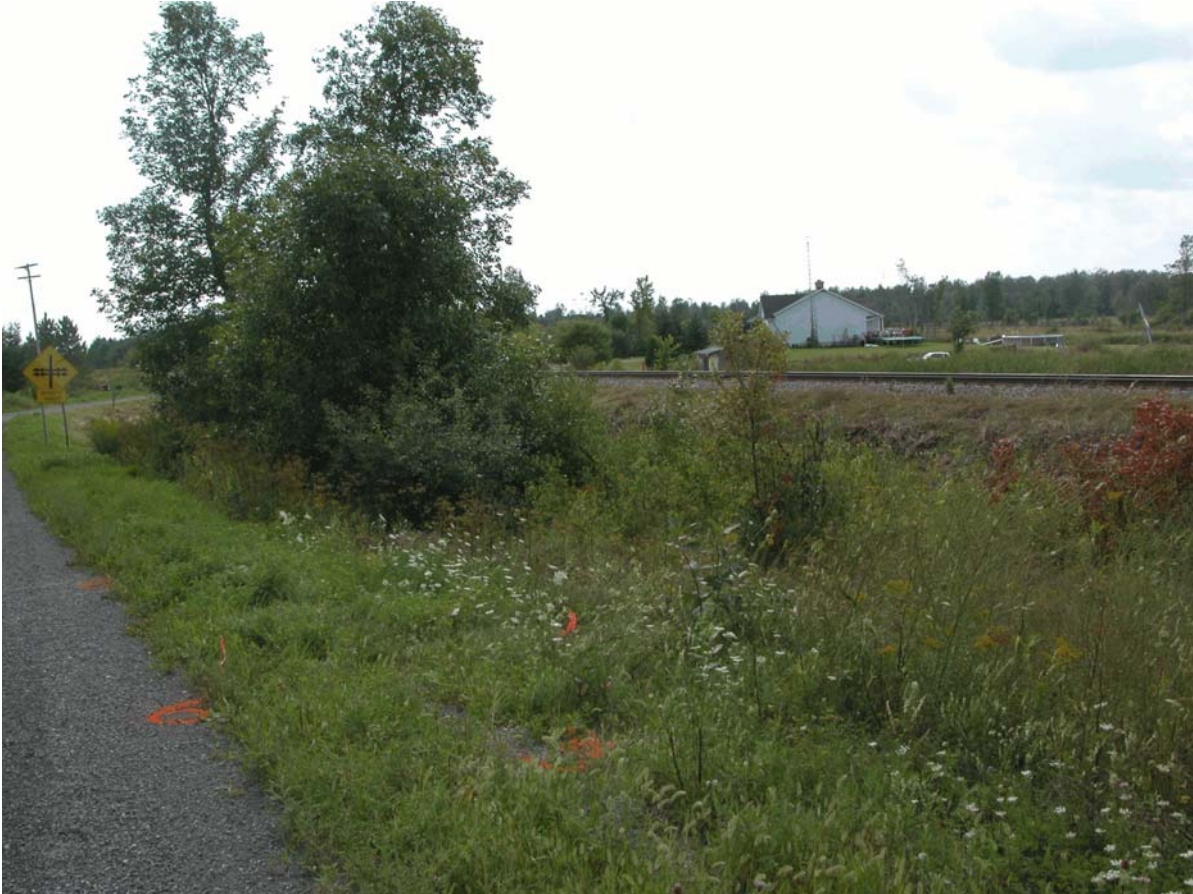
Photo 1. Driver's view to the right of the approach of Kettles Road crossing

As the truck reached the crossing, it was likely oriented at the 52-degree crossing angle. In this position, the driver's right view towards the east was obstructed by the truck's dump box. The only available sight-line towards the east was through the passenger-side window through which the train would have been visible to the driver only when it was approximately 200 feet (61 m) from the crossing. With the train travelling at 93 mph, this distance represented approximately 1.5 seconds of time before the collision. Therefore, the truck driver either did not see the train, or else saw it with too little time to react. The acute angle of the crossing, in combination with the lack of a rear window view, prevented the driver from observing the approaching train.

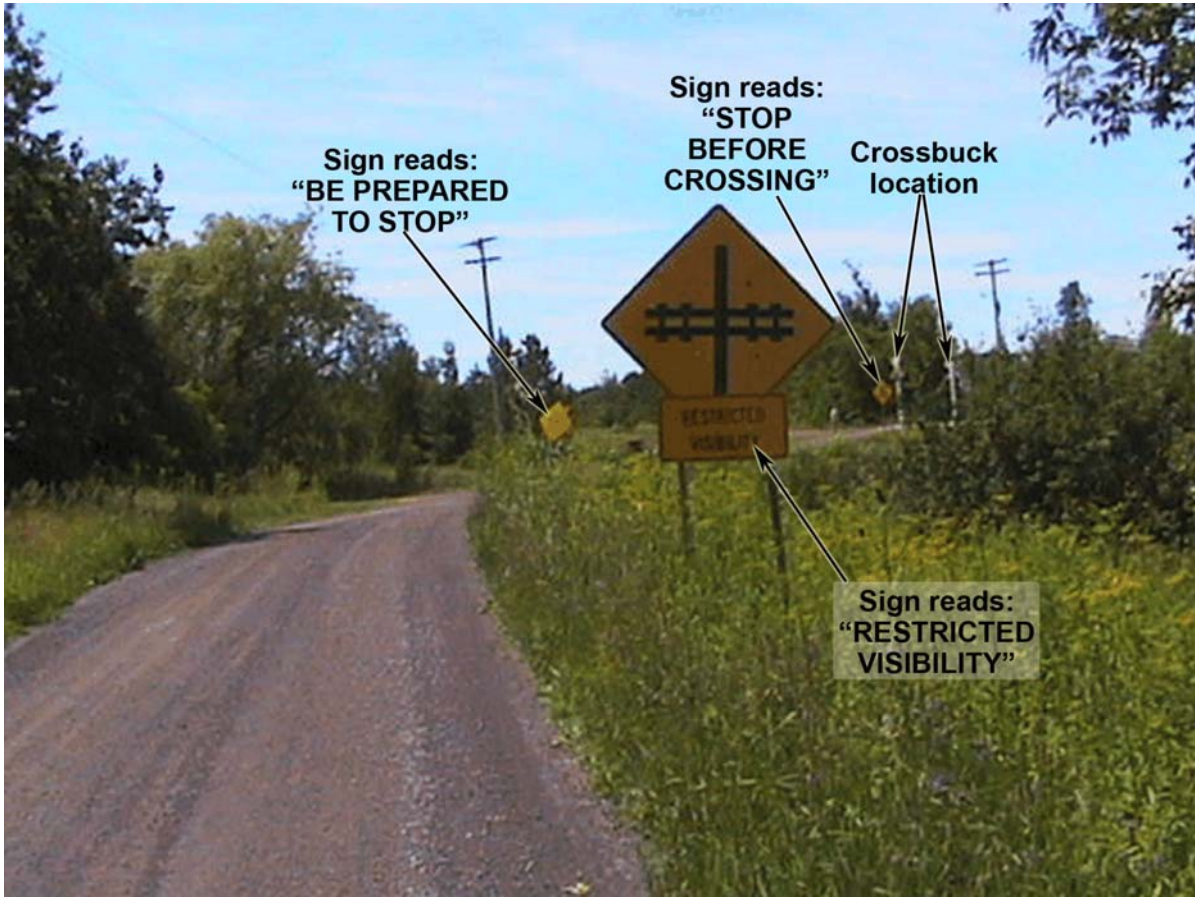
Photo 2. Scheme 2 signs for the acute-angled crossing

At the Kettles Road crossing, the first of the three Ontario scheme 2 signs indicated that the road crossing was perpendicular to the track. But the road crossing is at an angle of 52 degrees, to the right side of an approaching northbound vehicle, and a more appropriate sign exists to indicate an angle crossing.

Since scheme 2 signs are designed and interpreted only as warnings, it is likely that many drivers encountering the "Stop Before Crossing" sign will not stop, unless they see an approaching train.

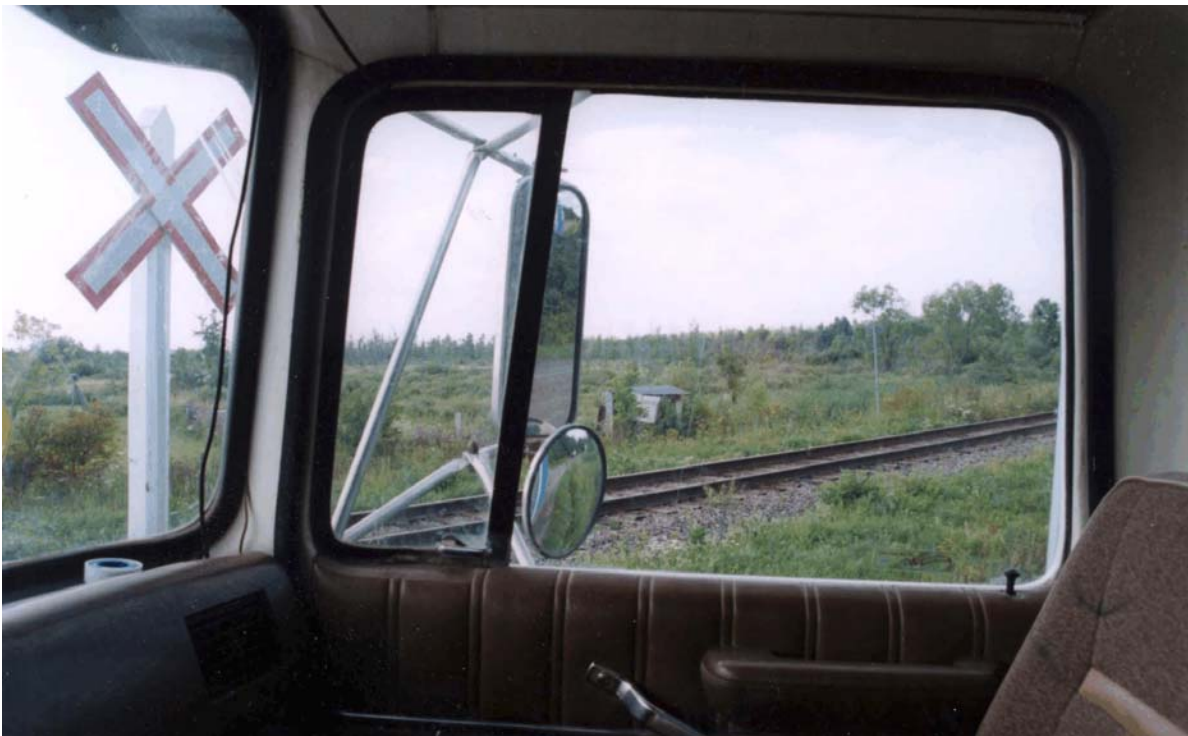
- For a driver of this style of Ford truck, travelling north, a westward train would only be visible when the train was approximately 200 feet (61 m) from the crossing (see Photo 3).

Photo 3. Driver's eastward view of tracks

However, in either scenario, due to the restricted visibility caused by the acute angle, the train would only have been visible for 1.5 seconds prior to its entering the crossing, and audible for only one second. Therefore, without having sufficient visual or auditory cues of the approaching train, the driver drove onto the crossing, and the truck was struck by the train.

Meetings were held between Transport Canada, the City of Ottawa, and VIA to discuss possible enhancements to the Kettles Road crossing. As a result of these meetings, the City of Ottawa retained a consulting company to undertake an environmental screening and preliminary design for the railway crossing. The proposed design included an improved intersection angle, road profile, asphalt surface, elimination of one private rail crossing, and the installation of railway crossing signals, bells, and short-arm gates. The outcome of the proposals to date includes the interim placement of modified advanced warning signs and stop signs. The grade of the crossing has been widened and paved, sight-lines have been improved, and the intersection angle is now 70 degrees. Installation of an automated crossing warning system consisting of flashing lights, bell, and gates was underway as of January 2006.
